Tree Survey and Arboricultural Method Statement for Park Farm Cottage Stubton

4th May 2023

Revised 25th October 2023

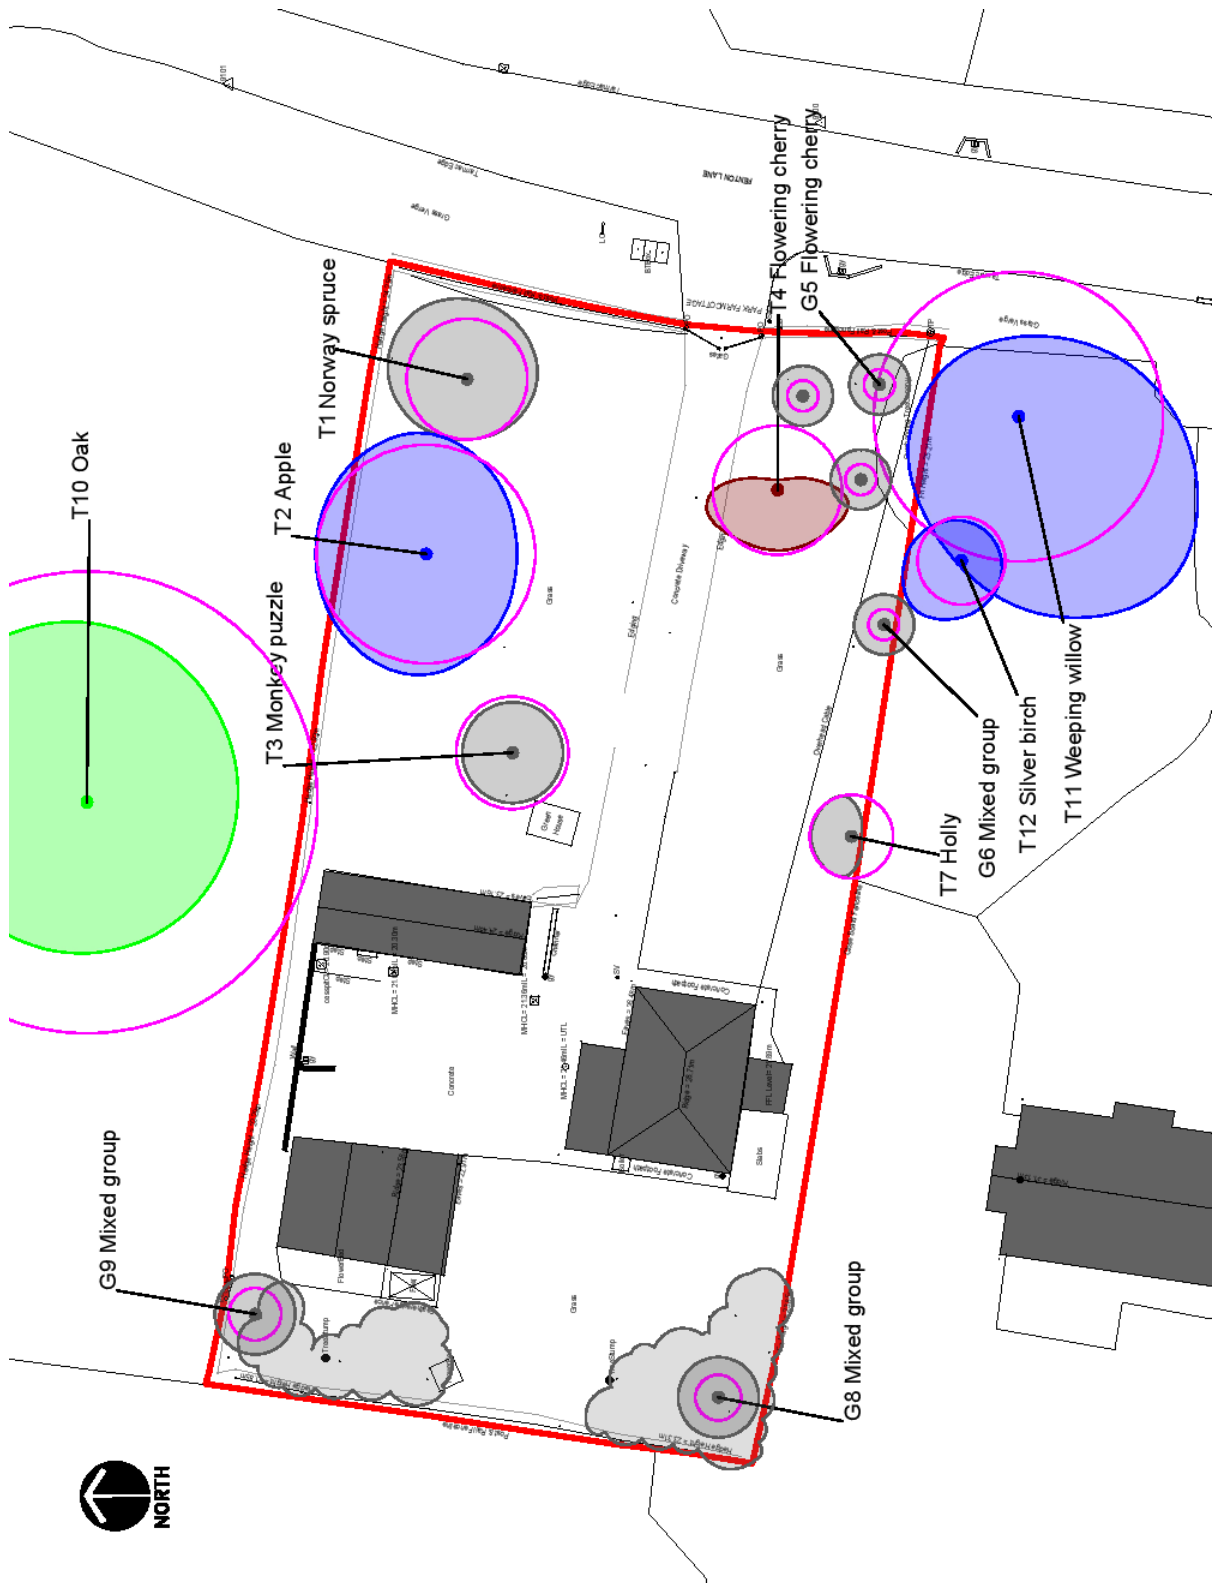
Tree Survey Plan

Shaded outline shows tree canopy graded in accordance with BS5837; RPA shown in magenta. The position of the trees is not intended to infer ownership which should be clarified before any tree work is carried out.

This tree plan is also supplied as an AutoCAD dwg file, XREFerenced to the topographical model. The tree geometry including the canopy and RPA are stored as layers that can be easily imported and overlaid onto a design layout to produce a tree constraints plan. Note: the CAD drawing units are metres.

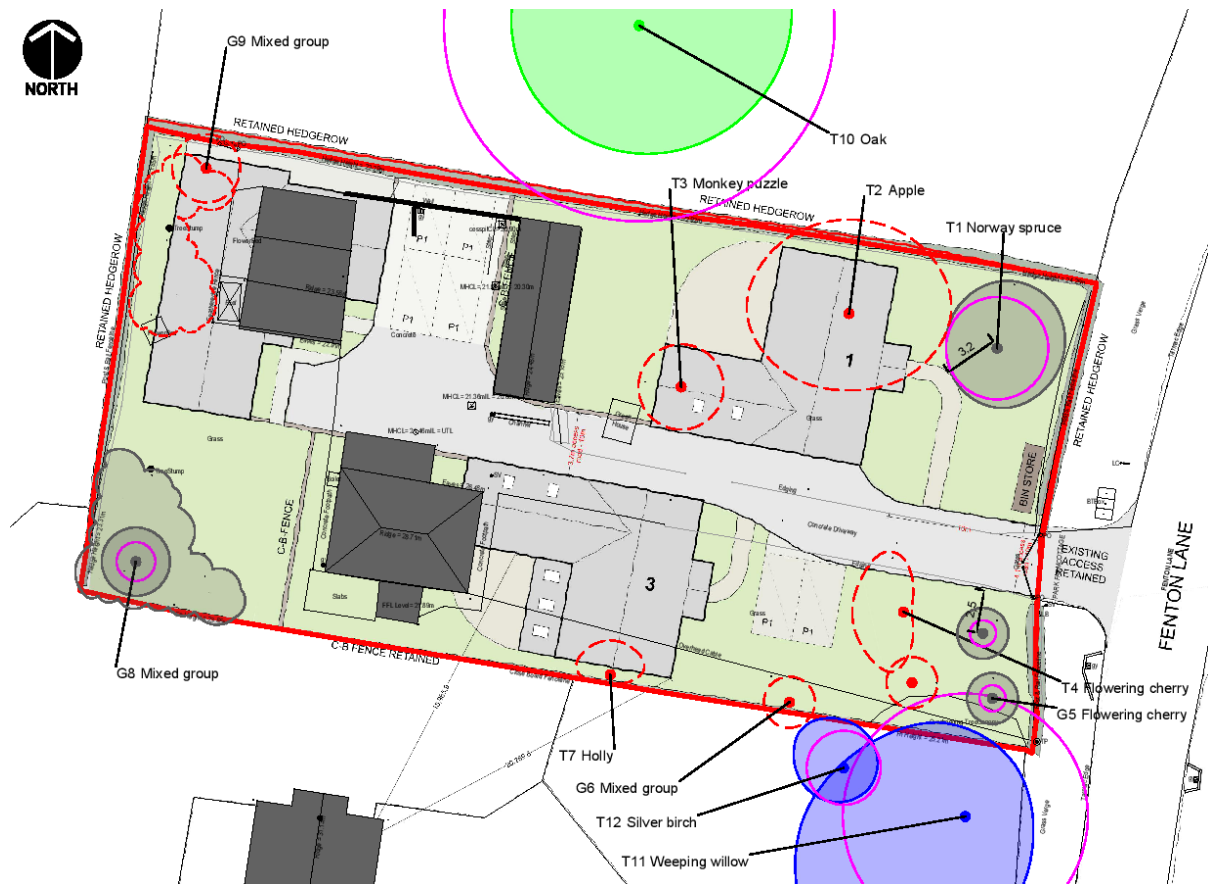
Trees to be removed shown with dashed outline. Root protection areas shown in magenta. Existing buildings with dark grey shading and proposed dwellings with light grey shading.

In order to accommodate the new dwellings, it will be necessary to remove T2 Apple, T3 Monkey puzzle, T4 Flowering cherry, one out the three young cherries in G5, T7 Holly and the mixed groups G6 and G9 as shown in the plan below.

The footprint of the development is outside of the root protection area of the retained trees so there is no requirement for specially engineered foundations.

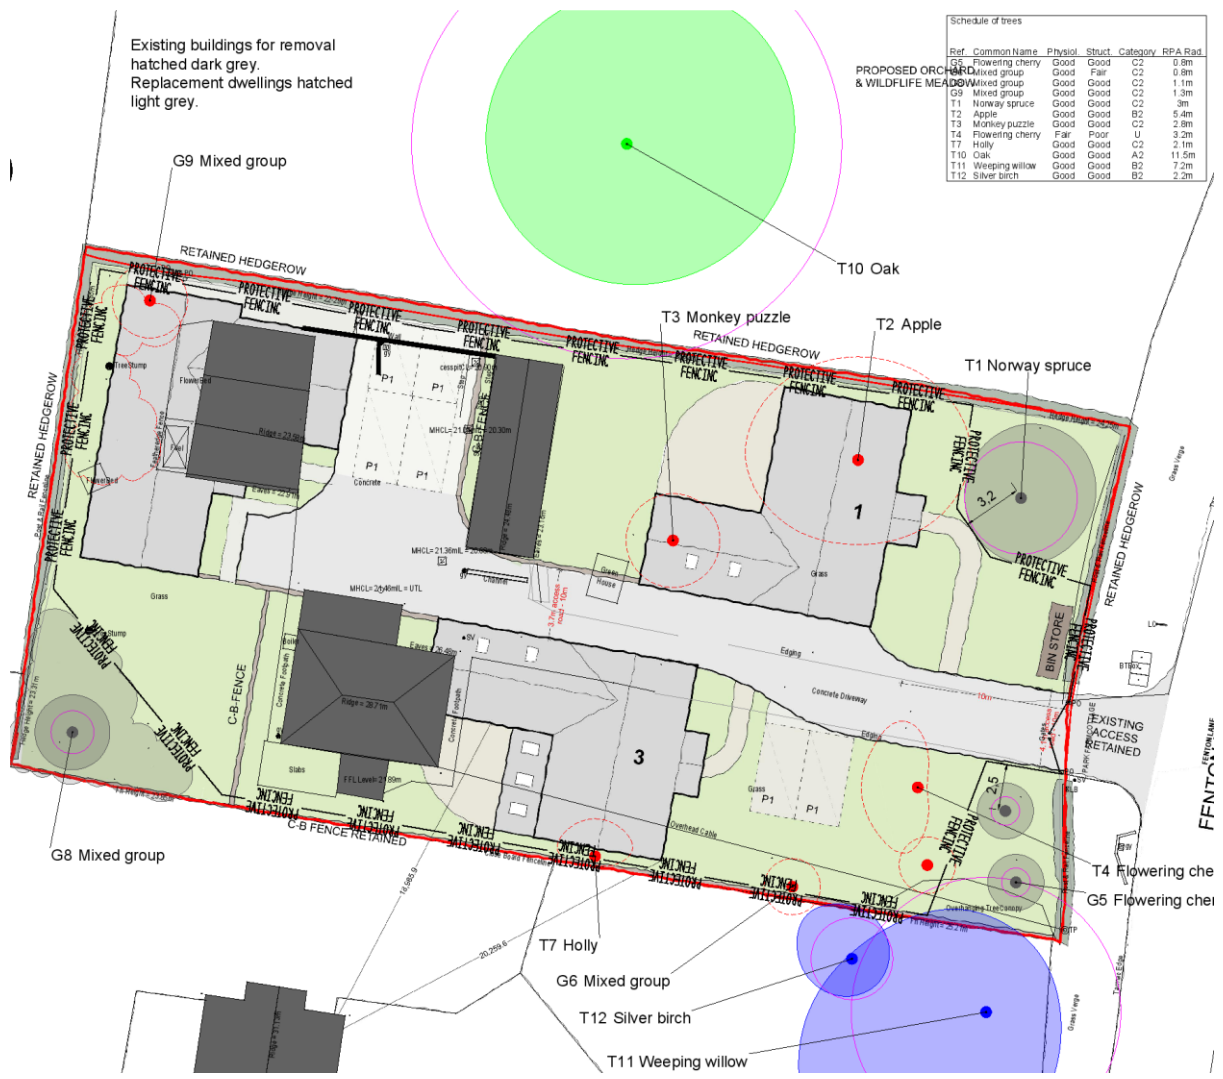
Extract from the tree protection plan showing siting of protective fencing.

All barriers will remain in place until completion of all works.
