Park Cottage, Fenton Road, Stubton, Newark

Bat Survey Report

June 2023

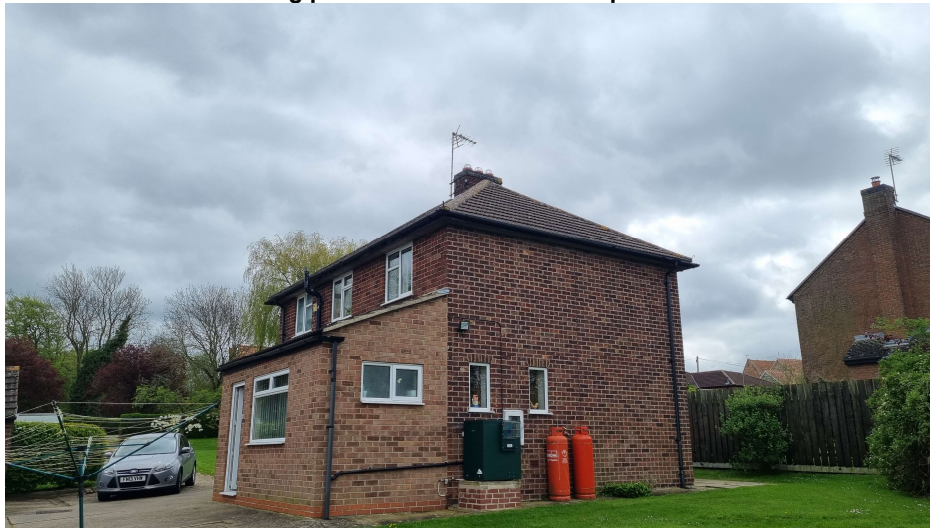
**Photo 1: External building photo from the western aspect**

- 4.10 B1 is a two-story brick-built dwelling, with a hipped concrete tile roof. The building has two single storey brick-built extensions, one to the northern aspect and one to the southern aspect. Both extensions have a single pitched concrete tile roof.

- 4.11 The building has a brick-built chimney located centrally on the southern aspect of the roof, this has associated lead flashings. Soffit boxes are present on the eaves of the main house, with minimal gaps present where it abuts the brickwork. Externally, the roof looks to be in general good condition, however there are a few areas of missing mortar along hipped areas and gaps where full concrete tiles have been cut to meet the ridge tile, creating small gaps.

- 4.12 The verges on both single-storey extensions are pointed with cement, which is in general good condition. However, there are gaps present where the verges meet the eaves, allowing access directly under the tiles, between the tiles and the underfelt. Timber facias area also present, which allow the plastic guttering to be directly fixed. There are limited gaps between the facias and the brickwork. These gaps are only suitable for individual bats. Where the tiles of these extensions meet the main house, lead flashing is also present. At the end of these lead areas gaps area present allowing access underneath, between the lead and brick/roof tiles.

- 4.13 B1 also includes uPVC windows and doors, with brick lintels, plastic guttering and associated downpipes. No other features of note were recorded during the survey.

- 4.16 B1 has been identified as holding MEDIUM potential to support roosting bats. The structure holds several potential access points into areas suitable for crevices roosting bats.

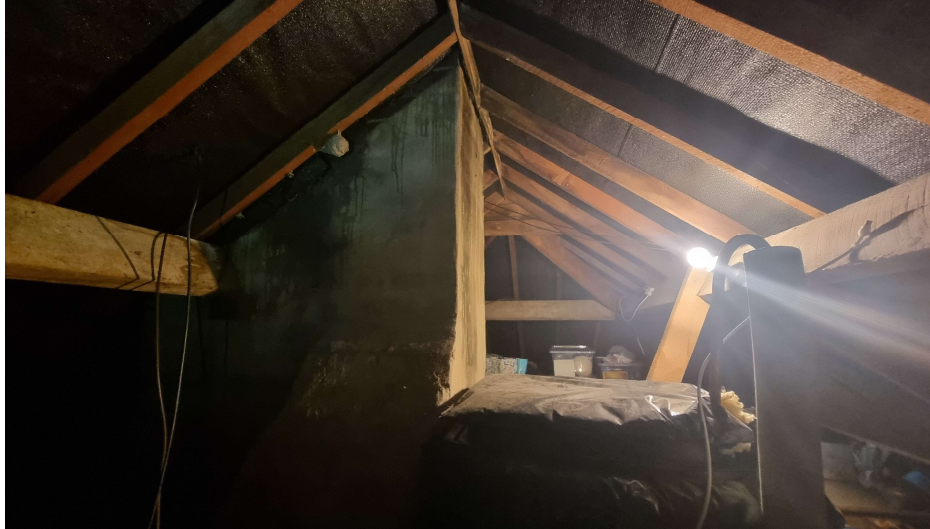
**Photo 2: B1 internal roof void showing bitumen underfelt.**

- 4.14 Internally B1, supports a loft space within the main house, and this is used for general storage, accessible via a drop-down ladder and is fitted with lighting. The roof structure is formed with rough sawn timber, which provides the hipped shape to the roof. Traditional bitumen underfelt is present and therefore inspection of the gaps between the tile and the bitumen is not possible. The chimney breast is concrete rendered, and has minimal gaps present where it extends through the roof structure.

- 4.15 All timbers were inspected for presence of bats. The timbers were found to have a small amount of cobwebs, with NO bats found. NO evidence of bats was found within the loft area, with all surfaces inspected. Several wasps' nests were found in early stages of development.

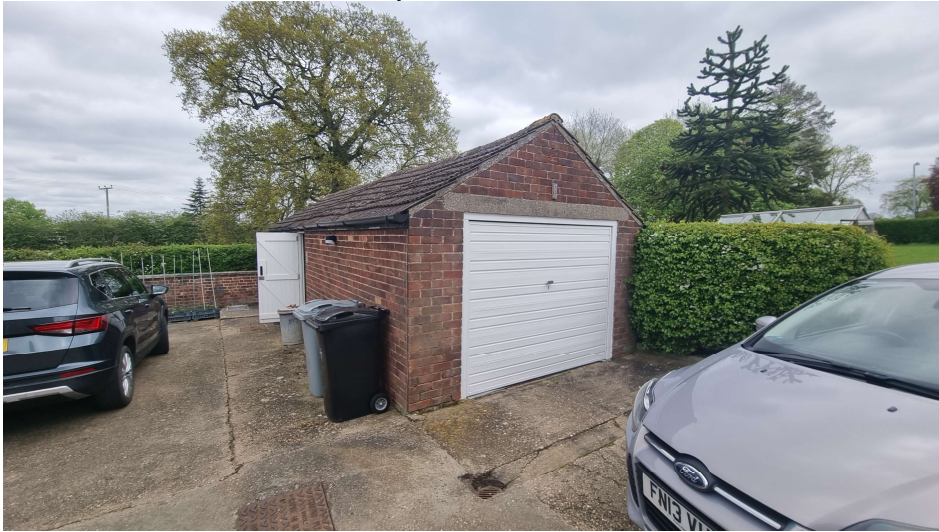
**Photo 2: B2 From the Southern Aspect**

- 4.17 B2 is a single storey-brick built garage / outbuilding with a pitched concrete tiled roof. It has pointed verges, plastic guttering supported by timber fascias, and a mix of concrete and wooden lintels. On the southern aspect, a metal upward opening garage door is present. On the western side, wooden doors allow access into the main body of the building, and access to a further two small stores. The eastern aspect hosts timber framed windows. The roof is formed by concrete tiles, with a concrete tile ridge. It is in reasonable condition, with some areas of missing mortar. There are gaps present at the eaves, allowing access into the building. This also allows water and light ingress, and it has been noted that the timber wall plate and bitumen underfelt has degraded because of this associated water damage.

- 4.18 Internally the building is open to the roof line with no void present. The roof is formed by rough sawn timber with bitumen underfelt present. The garage area is open, with additional lighting present. Evidence of water ingress can be found in the western aspect with damage to the underfelt, which is rotten and torn. Other areas of damage to the felt can be seen near to the verge, and other areas where it has torn/degraded over time. At the northern extent, over the top of the two smaller stores, a mezzanine type floor was present offering a raised storage area. The internal area was fully inspected with no evidence of bats found, the roofing timbers were inspected and found to have some light cobwebbing, but no signs of bat activity.

- 4.19 The building at present holds LOW suitability for roosting bats, however with the general repair of the roof, it is anticipated that with no human intervention the potential will reduce to negligible.

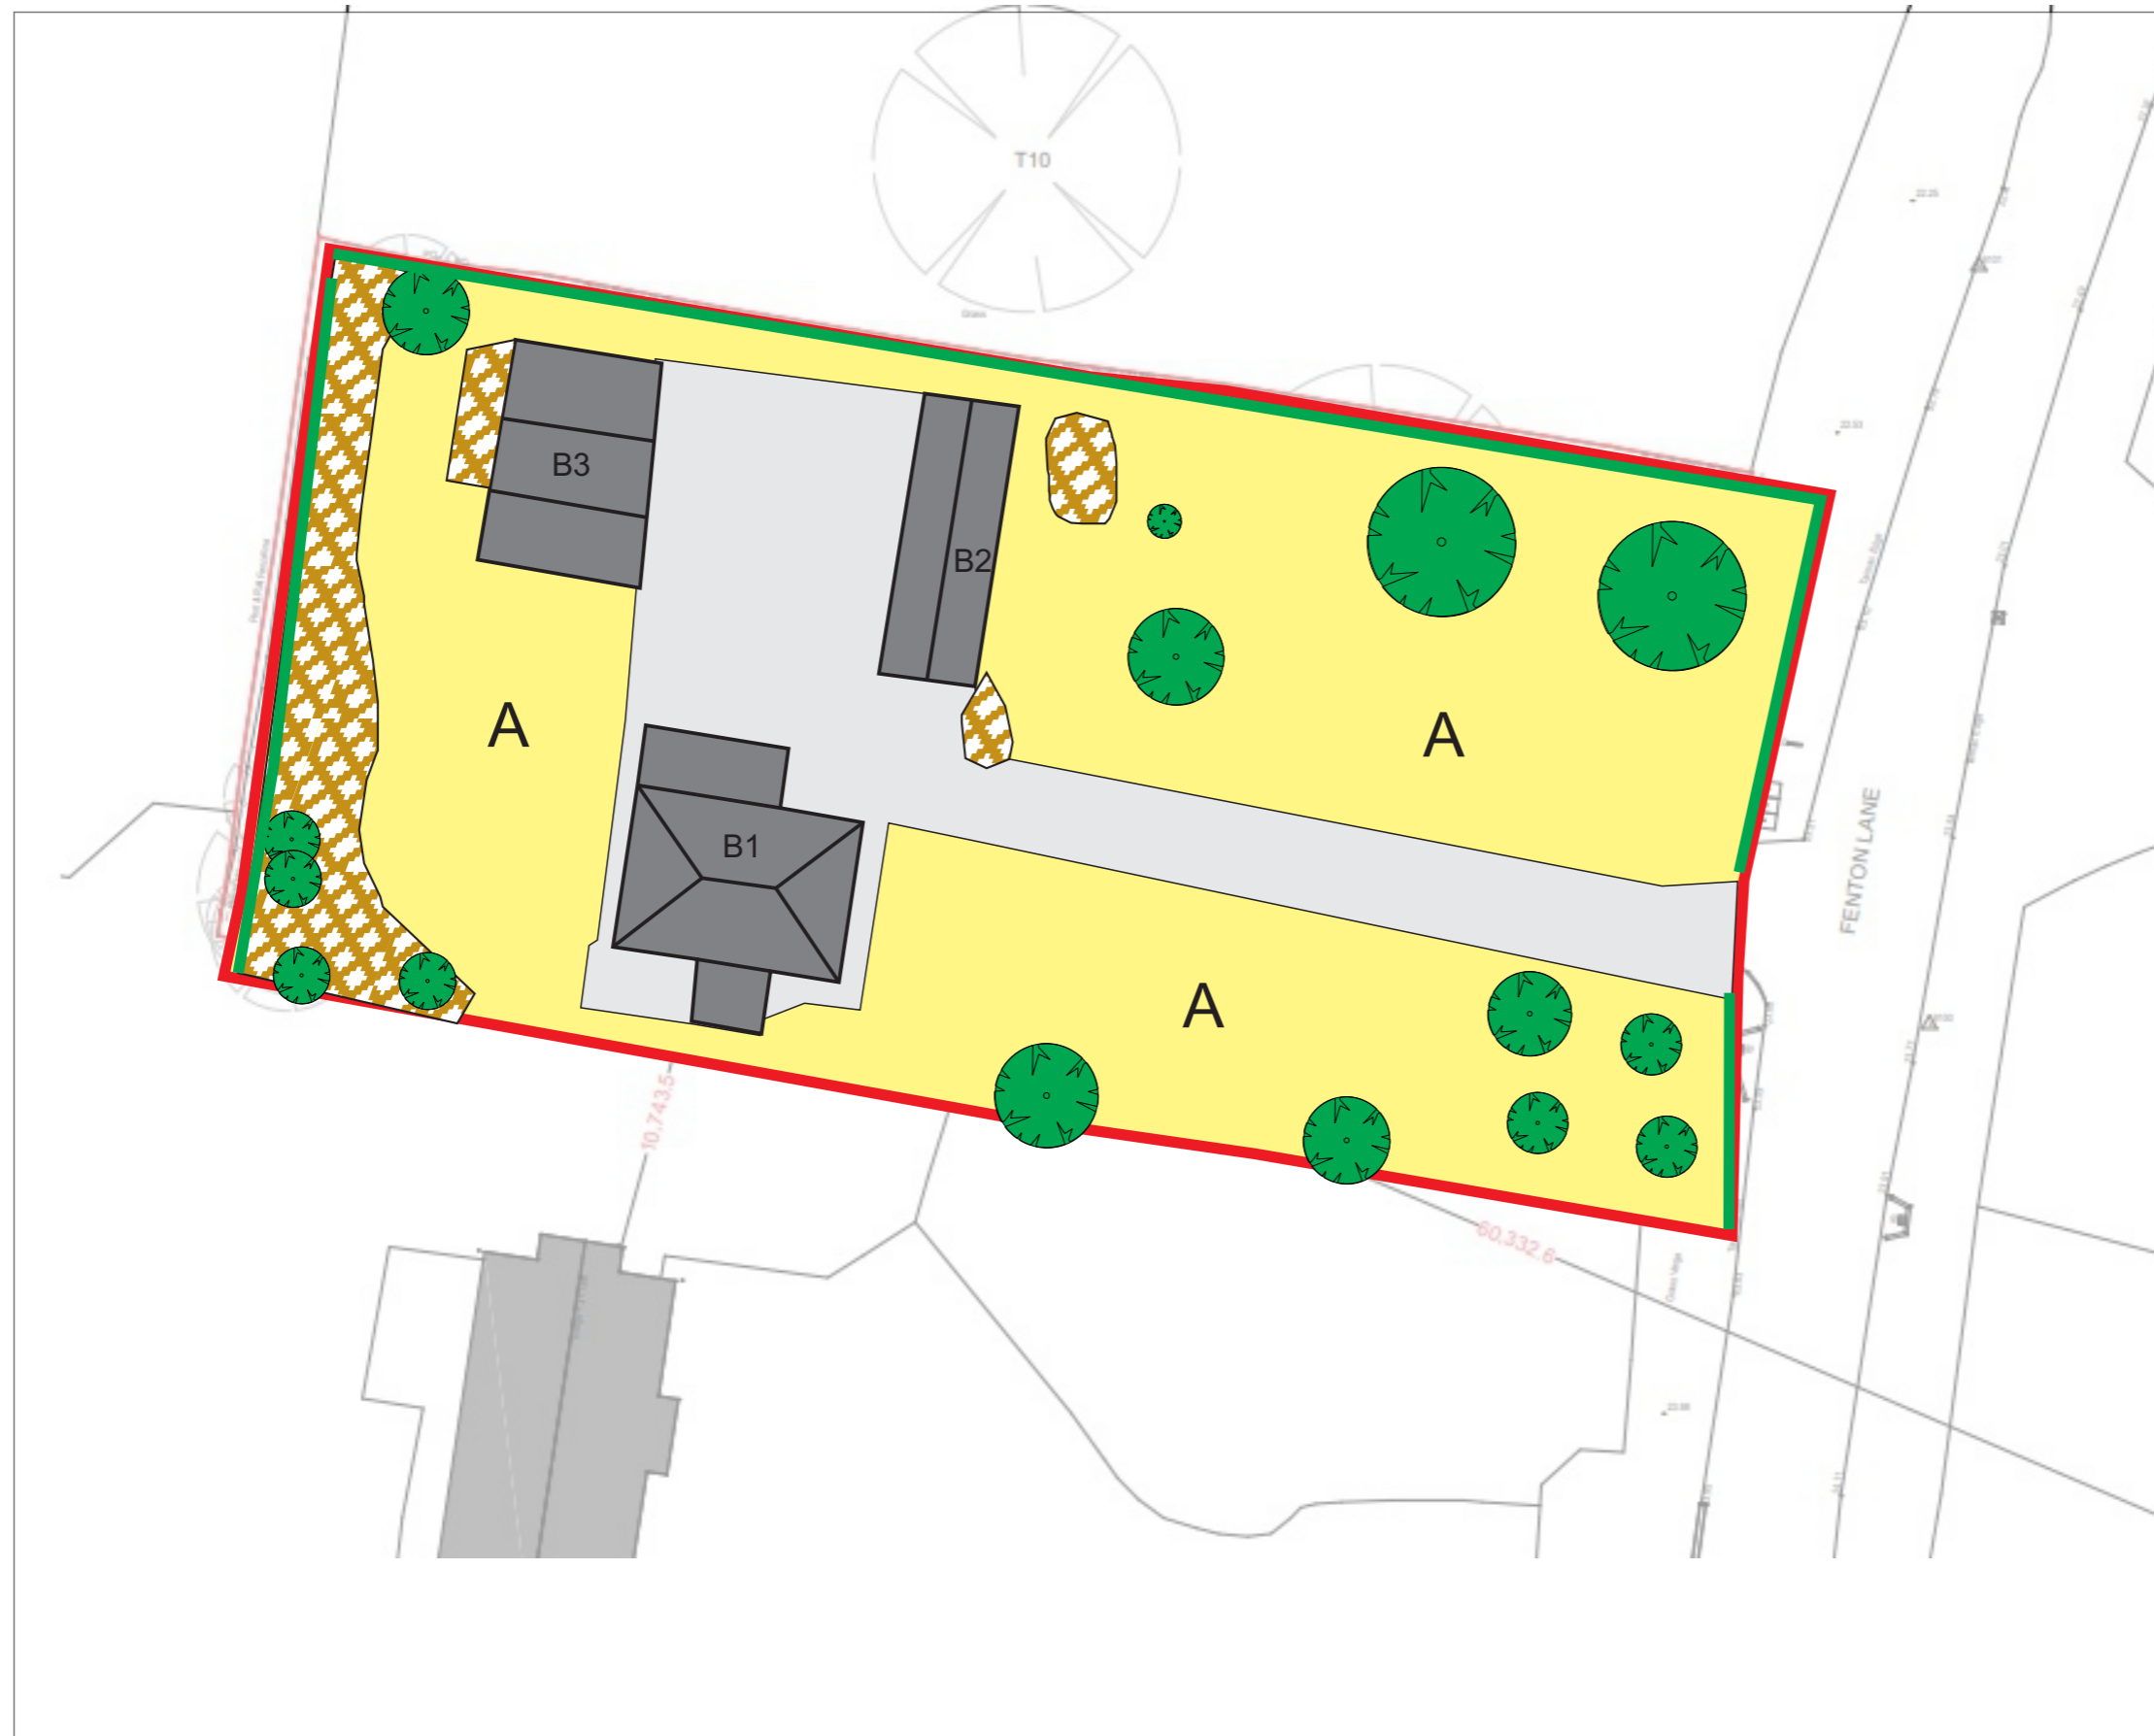
**Figure 2: Phase 1 Plan**

- 4.4 The site which is located on the northwest extent of the village of Stubton, is accessible from Fenton Road. The site is approximately 0.3 acres in size, and is a residential property, a detached 2-story dwelling, with two associated garages, a driveway and large garden which is maintained as such.

- 4.5 The site is bounded on its southern extent by another residential property, its eastern aspect runs parallel to Fenton Road, whilst its northern and western aspects are bounded by open pastoral fields.

- 4.6 The boundary between the site and the residential property to the south is formed by a wooden close board fence. The boundaries along the northern and western edges are formed by newly planted (less than 10 years) hedgerows, with species such as privet, hawthorn and sycamore present. The eastern boundary is formed by a single species privet hedgerow. All hedgerows onsite are managed as typical garden boundaries and are immature with low ecological value.

- 4.7 The majority of the site is formed by short mown garden lawn, this is cut regularly. This provides limited ecological value to the site. A small number of individual trees are present on site, including a single monkey puzzle tree and three holly trees/bushes. Fruit trees, such as apple and cherry are also present within the site but do not meet the criteria for orchard status.

- 4.9 There are three buildings onsite, these are B1 (a two-story detached house), B2 (a single-story brick garage/outbuilding) and B3 (which is a single-story prefabricated garage).
